west virginia department of environmental protection

**CONSENT ORDER  
ISSUED UNDER THE  
WATER POLLUTION CONTROL ACT  
WEST VIRGINIA CODE, CHAPTER 22, ARTICLE 11**

TO: MarkWest Liberty Midstream & Resources, L.L.C.      DATE: March 28, 2019  
Gregory Bezdek, SVP, NE Region  
4600 J Barry Ct. Ste 500  
Canonsburg, PA 15317      ORDER NO.: 8945

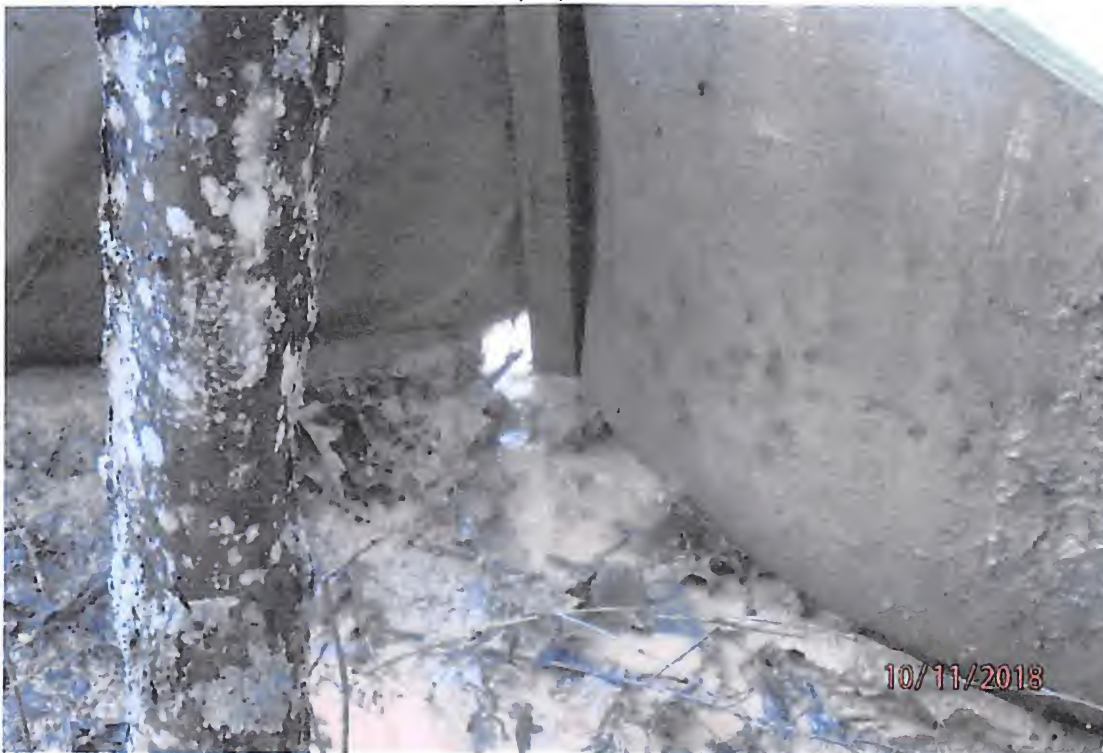
Perimeter control adjacent to 409+00 showing sediment laden water bypassing under the device.

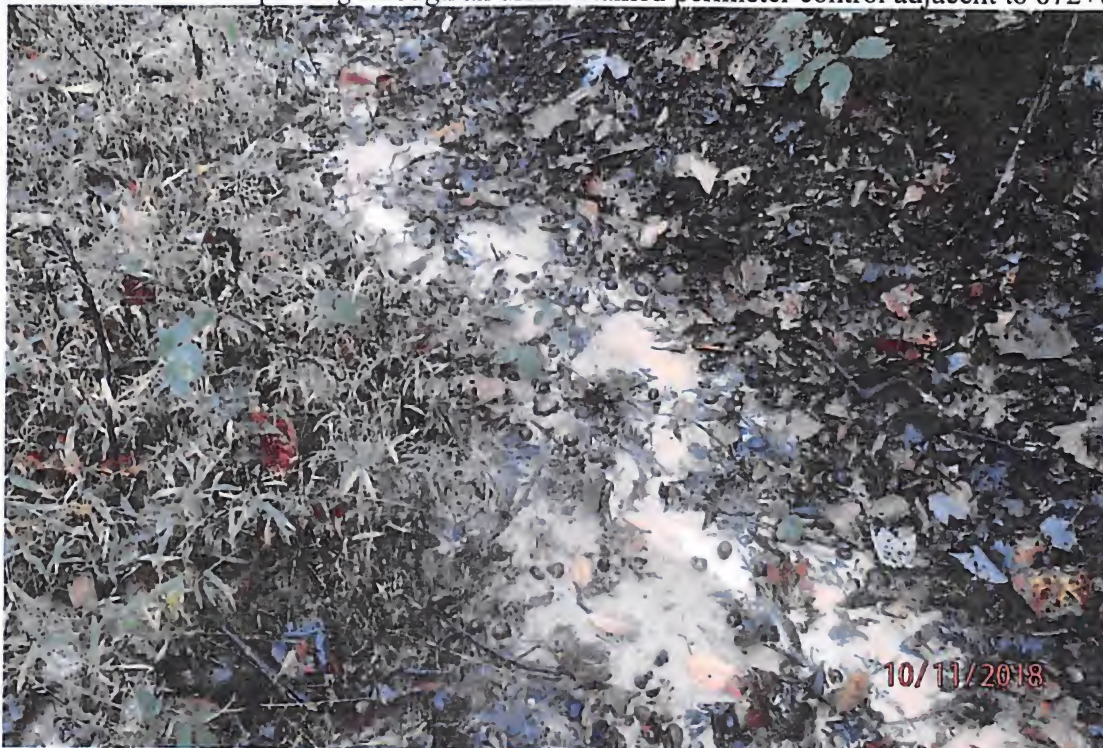
Sediment laden water passing through an unmaintained perimeter control adjacent to 872+00.

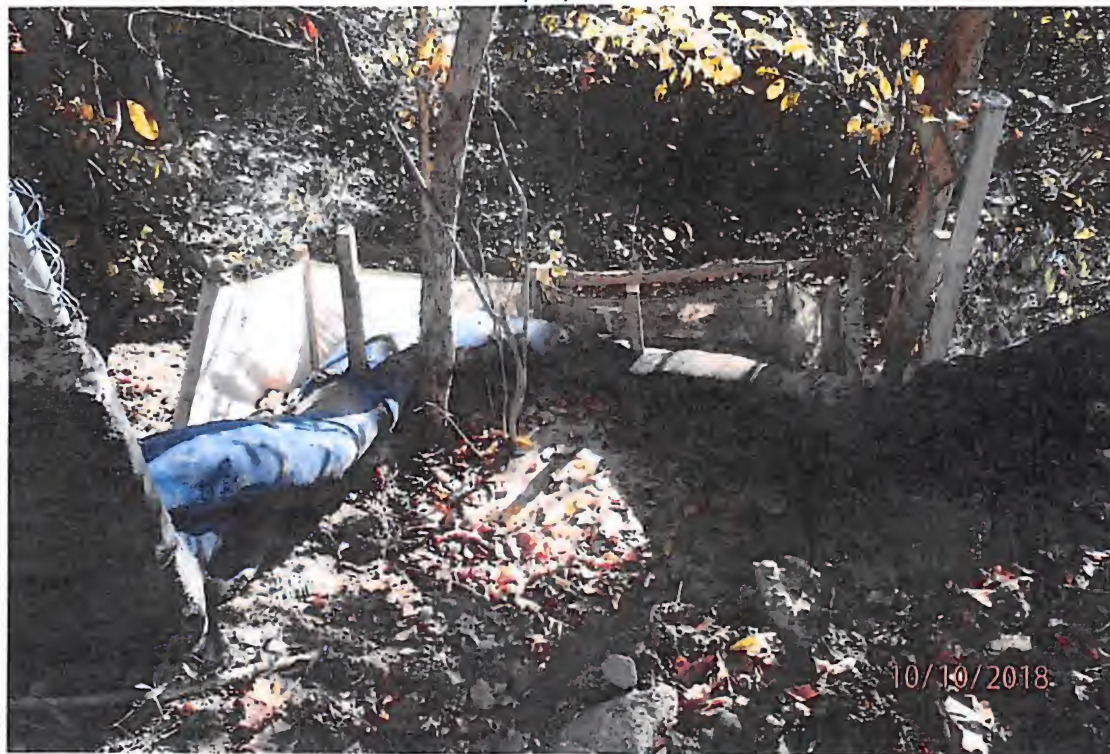
Offsite CNA deposits in UNT Buckeye Creek (UNT59) (39°16.844' X 80°41.115').

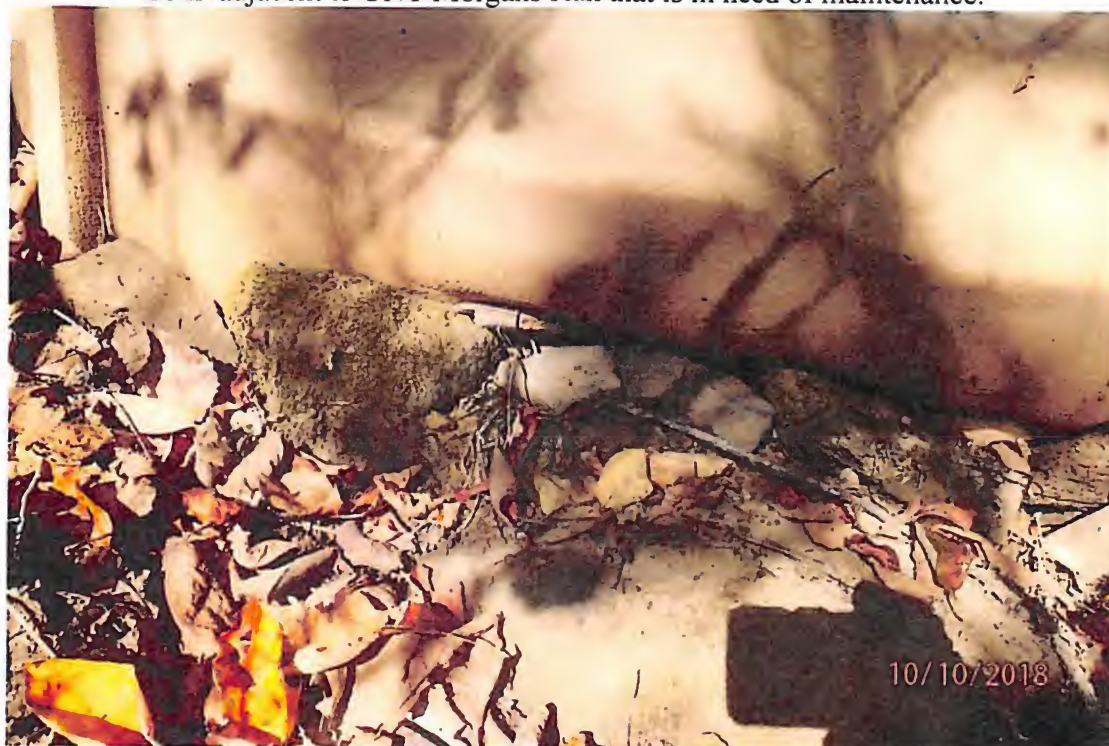
BMP adjacent to UNT Morgans Run that is in need of maintenance.

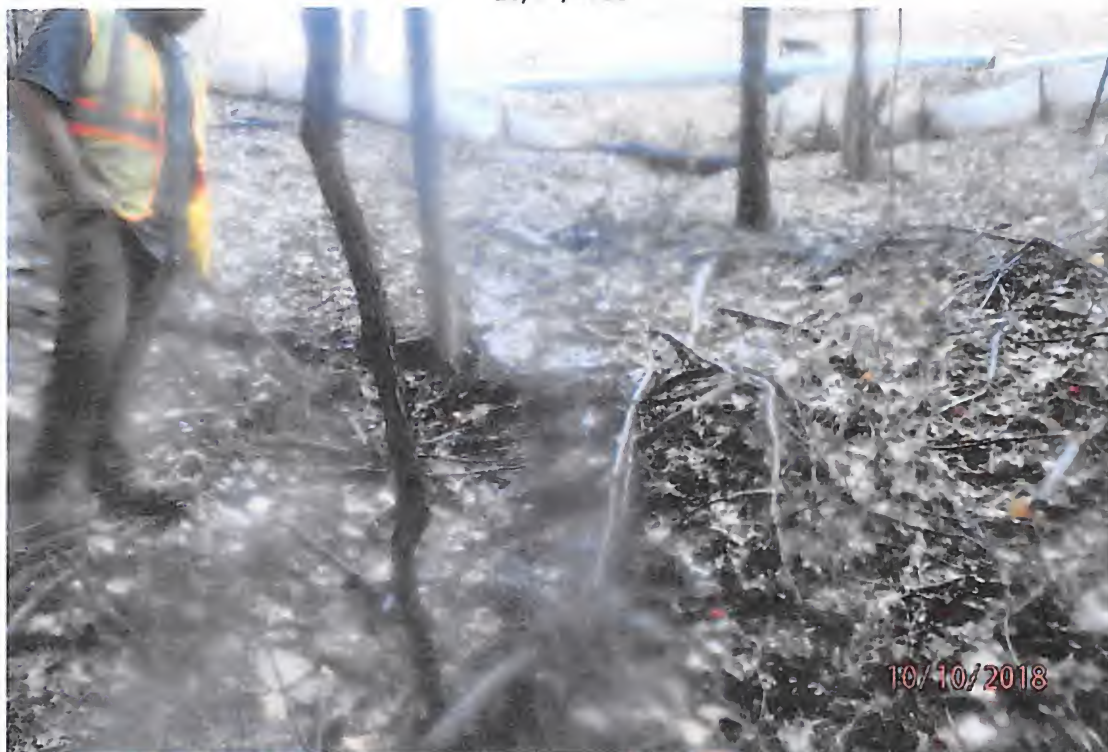
Downslope view of above pictured BMP showing rocks that have been placed in an area where sediment laden water is bypassing the BMP in an attempt to plug the area of bypass.

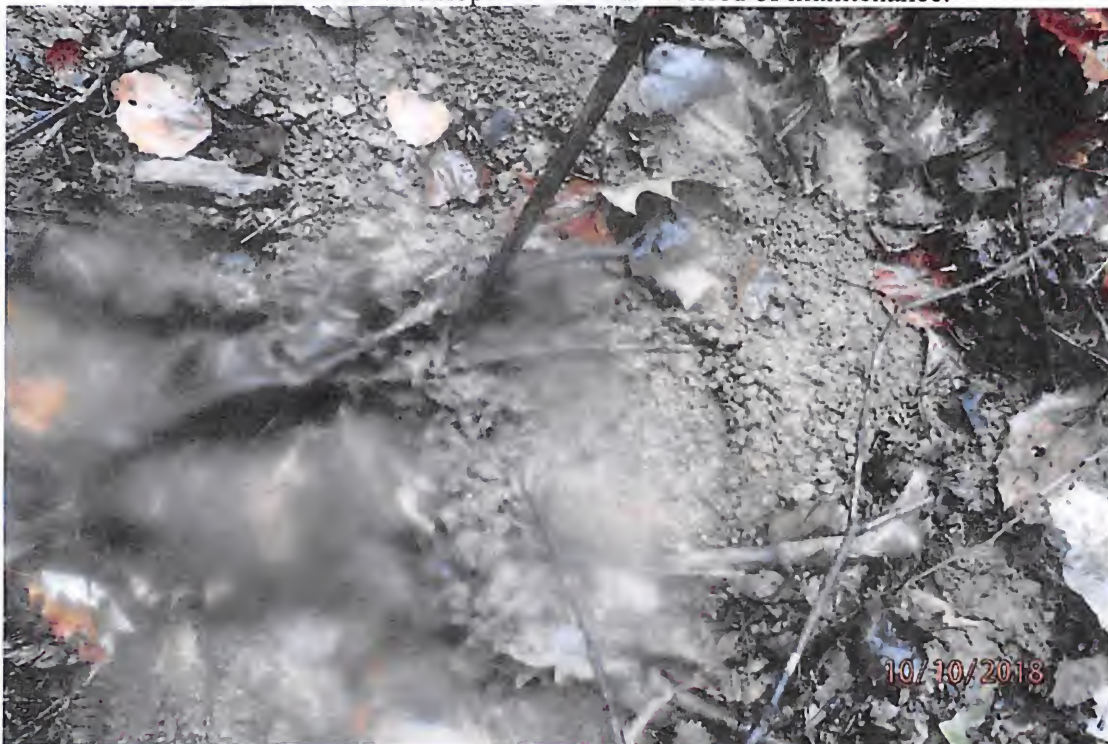
UNT Flint Run downslope of the BMP in need of maintenance.

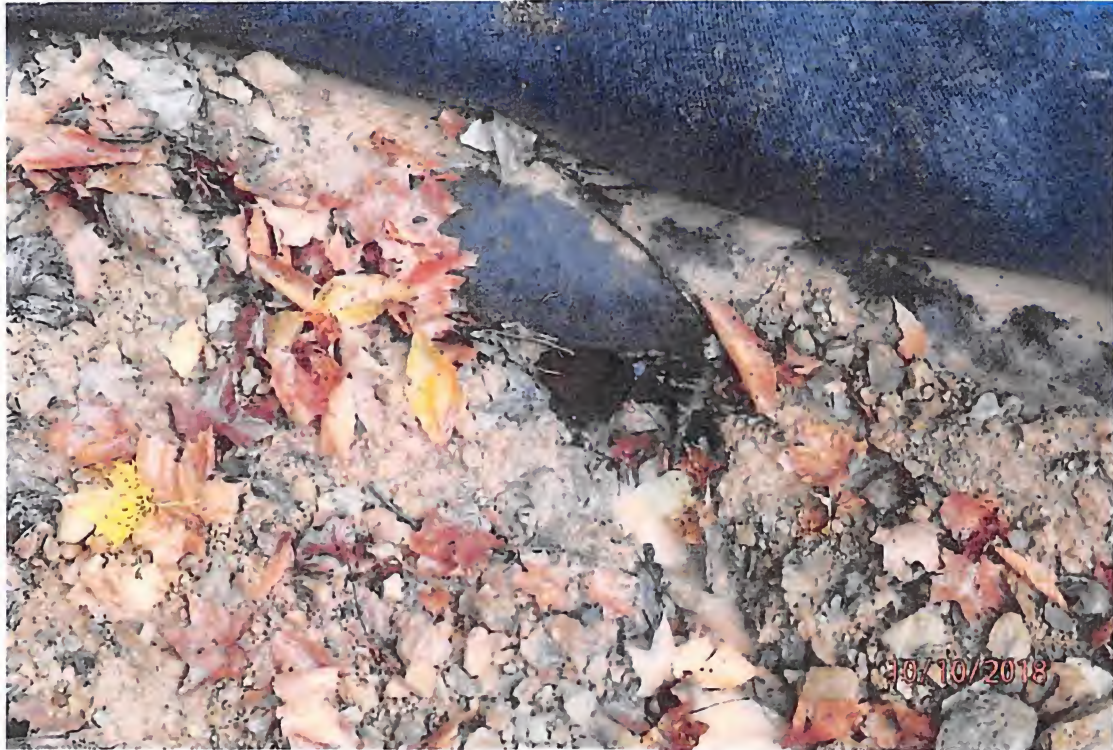
Offsite CNA distinctly visible settleable solids in UNT Beverlin Fork (UNT 21) (39°26.296' X 80°36.165').

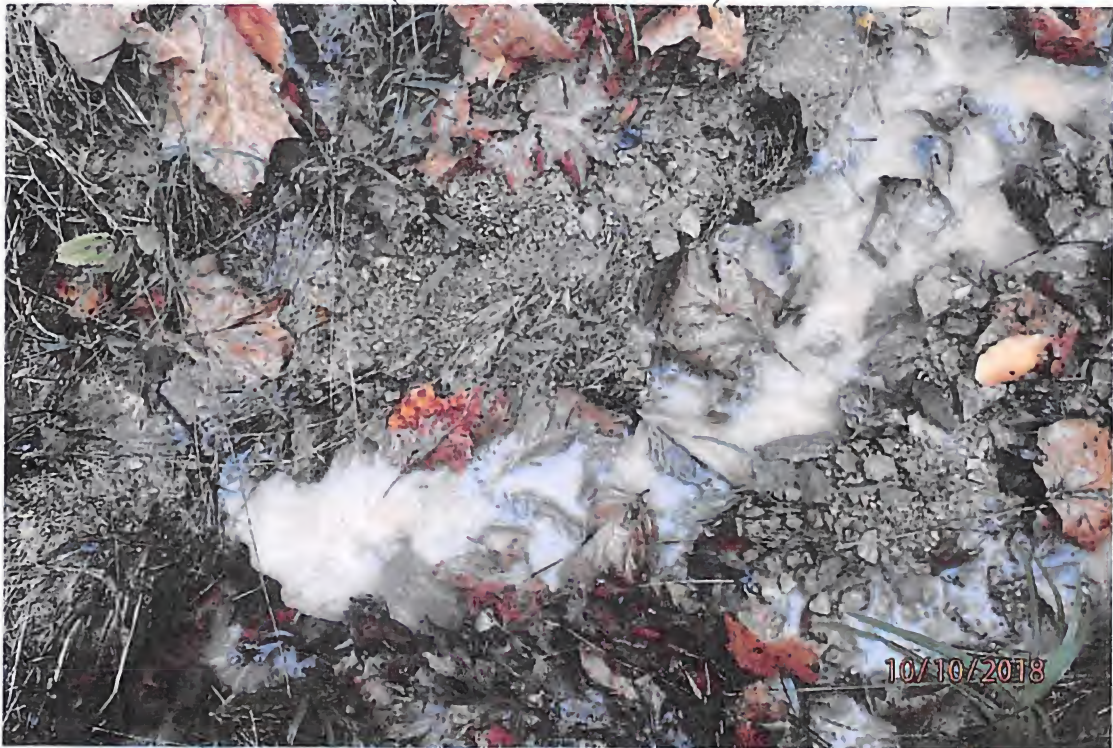
Sediment laden water bypassing under installed water bar terminus BMP adjacent to UNT Riggins Run (39°21.443' X 80°39.489').

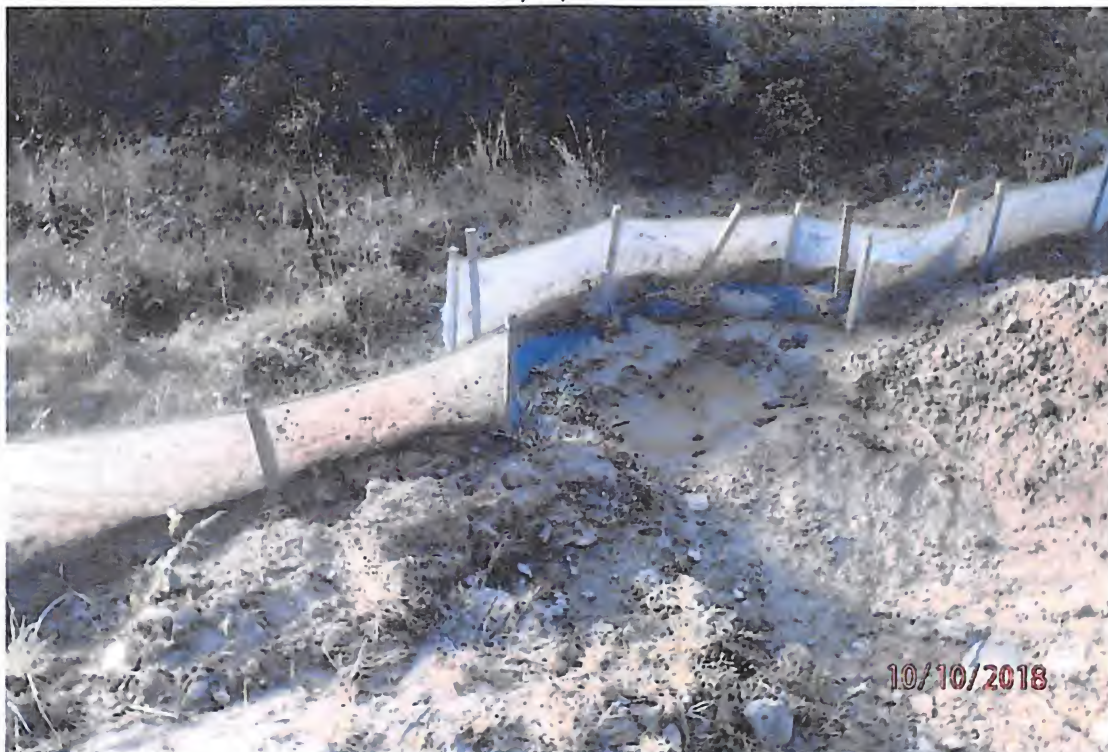
Installed diversion berm that lacks adequate outlets and is causing offsite sediment deposits due to overwhelmed outlet BMPs near 56+00.

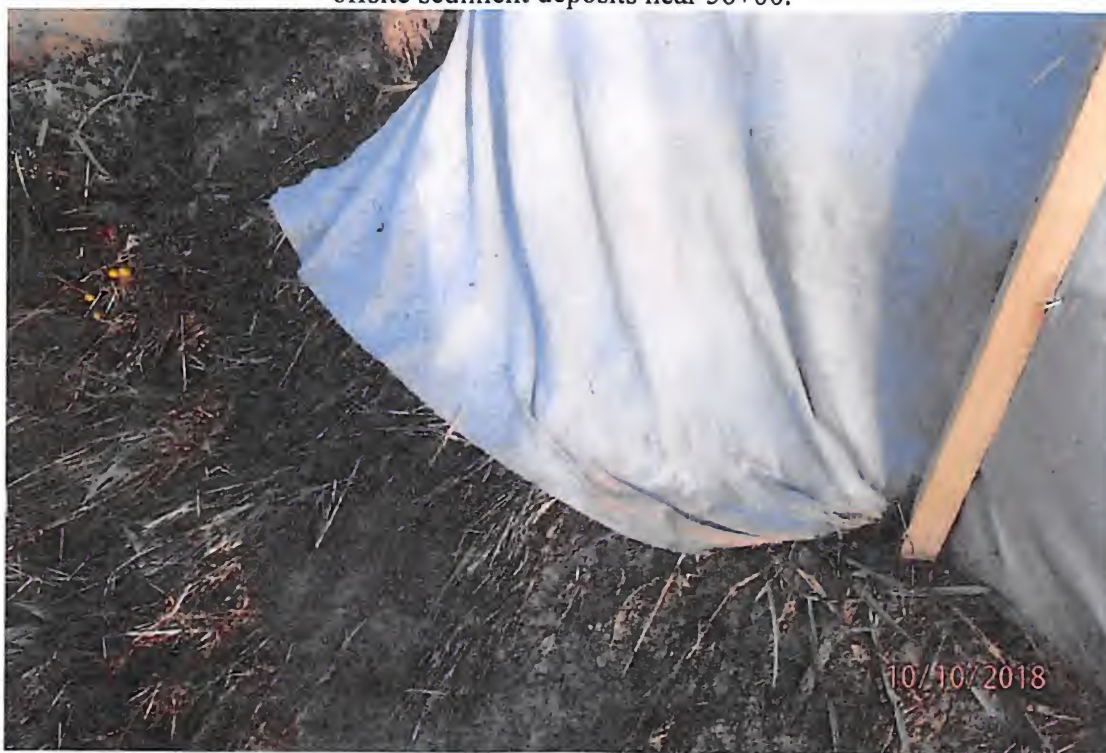
Diversion berm outlet BMP that has been overwhelmed and is in need of maintenance with associated offsite sediment deposits near 56+00.

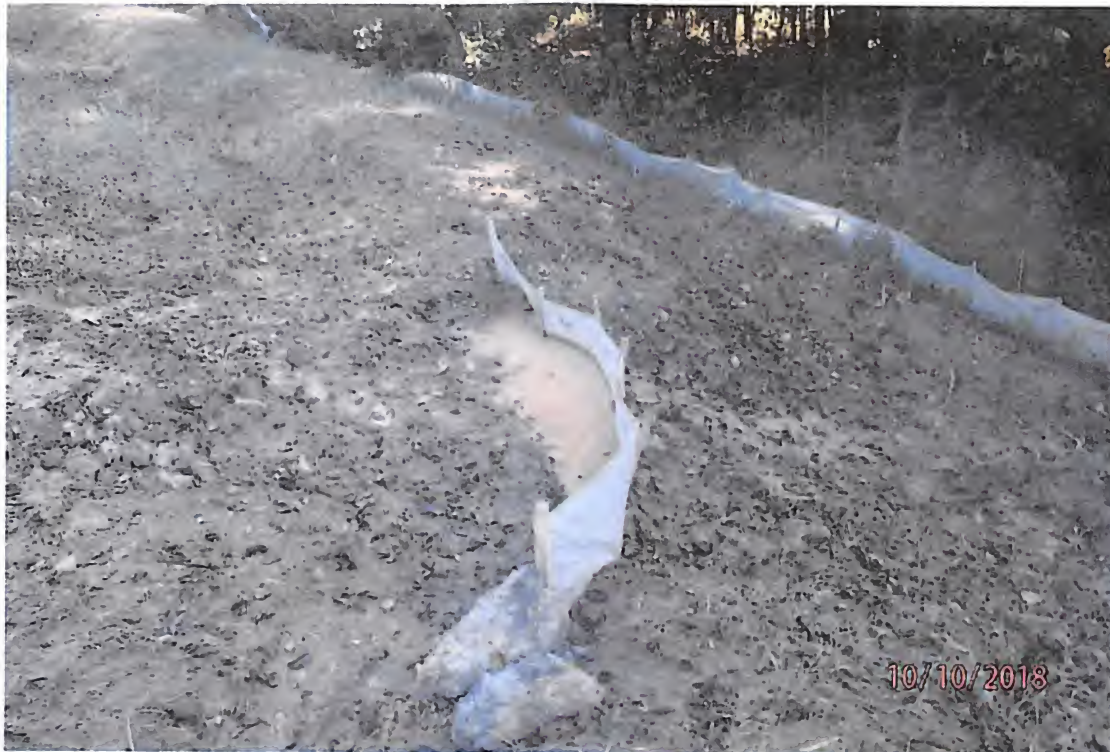
View of above pictured BMP from downslope showing its need for maintenance near 56+00.

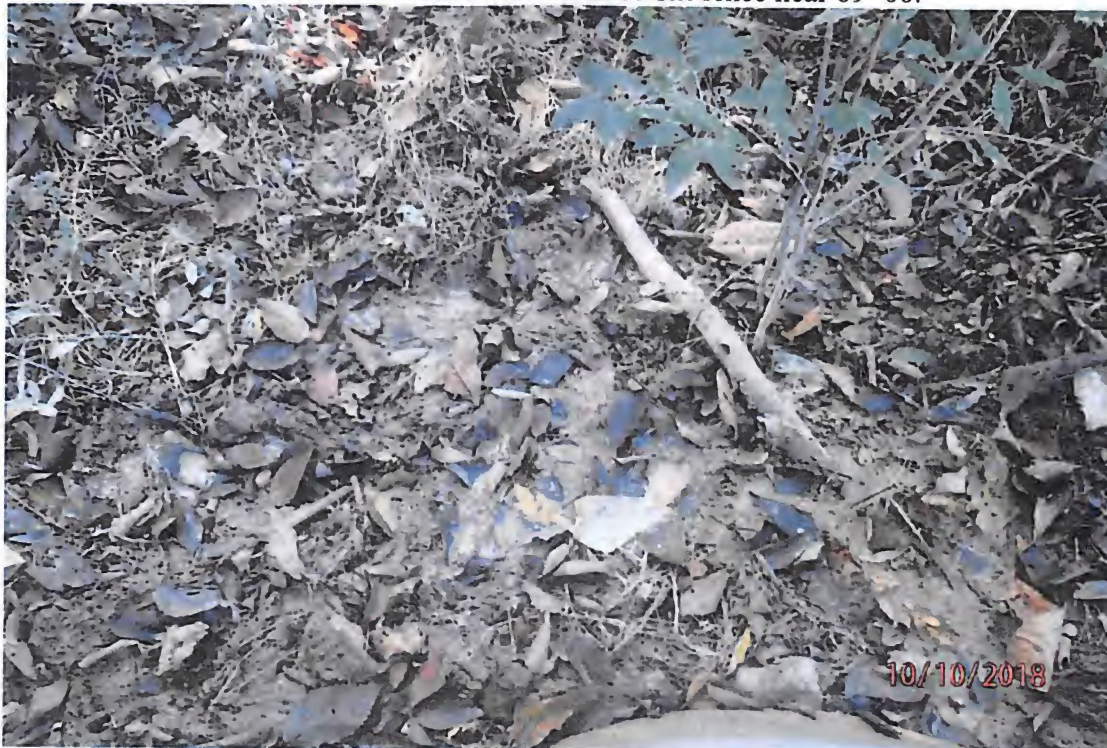
Diversion berm outlet with installed silt fence near 69+00.

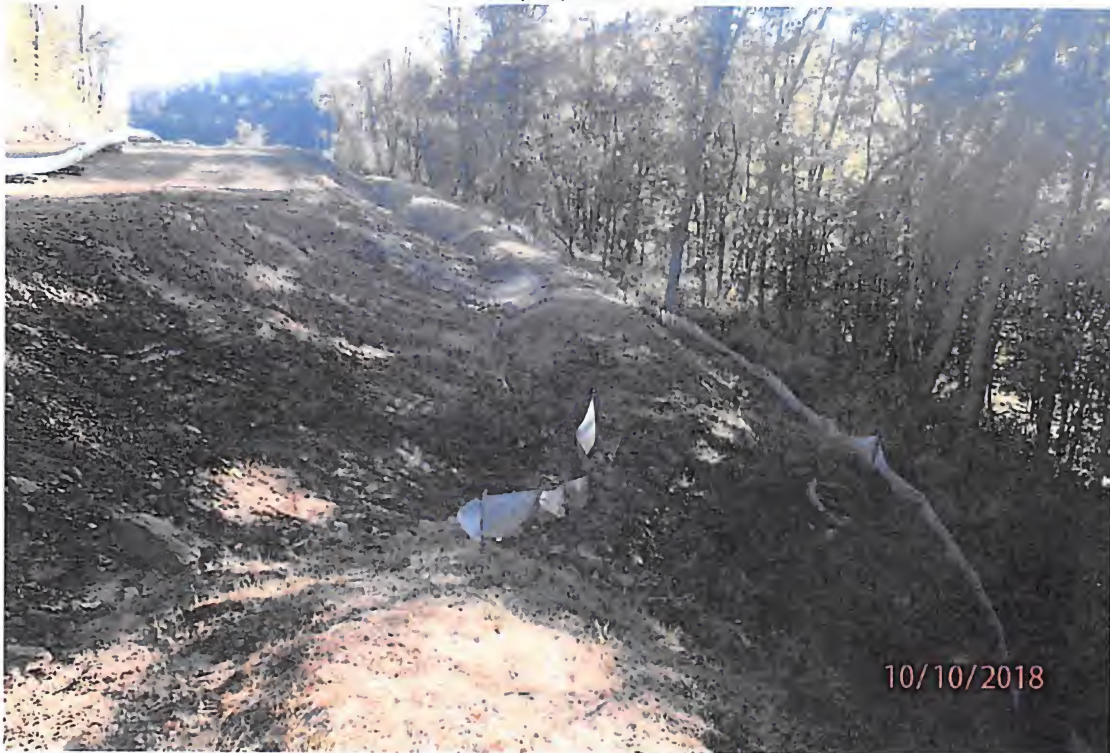
Offsite deposits as a result of above pictured deficiency near 132+00.

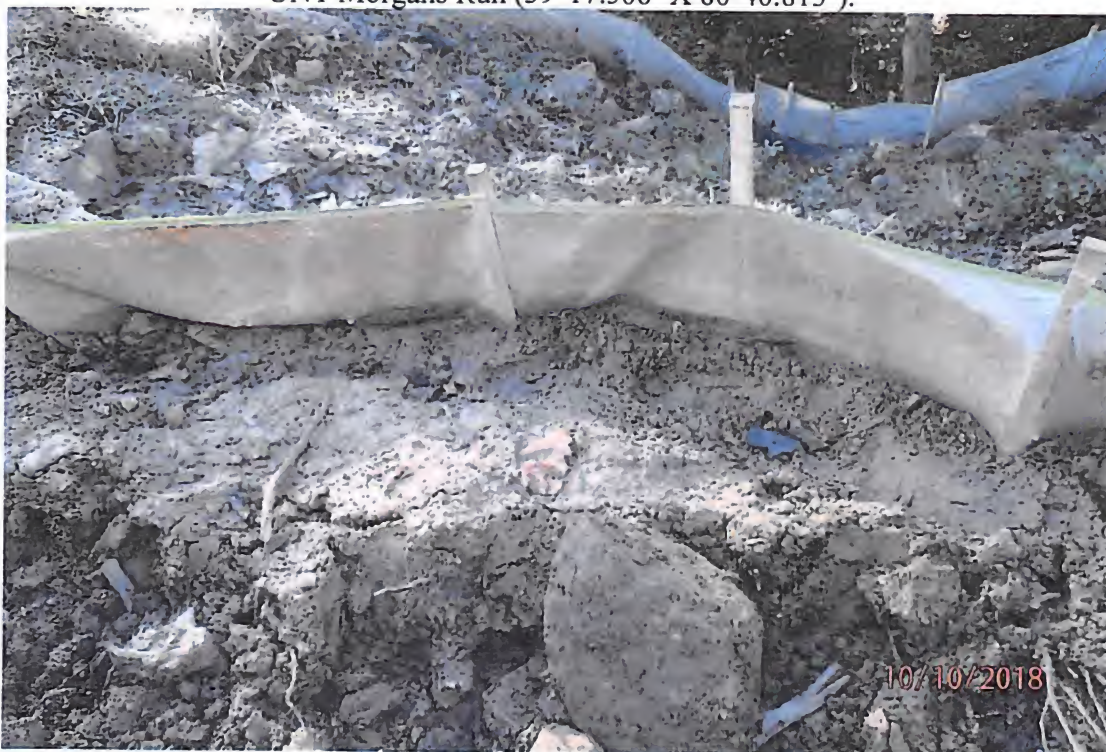
Diversion berm outlet BMP that has been overwhelmed and is associated with offsite CNA deposits near UNT Morgans Run (39°17.506' X 80°40.813').

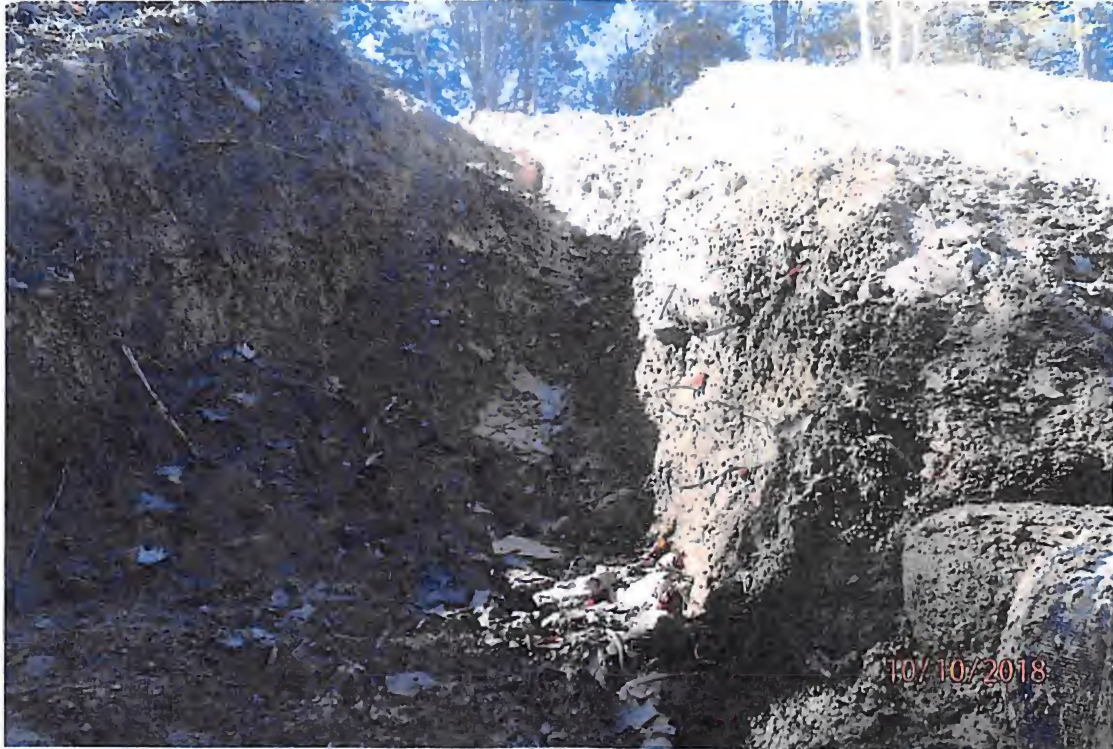
Fill slope erosion at water bar outlet adjacent to 105+00.

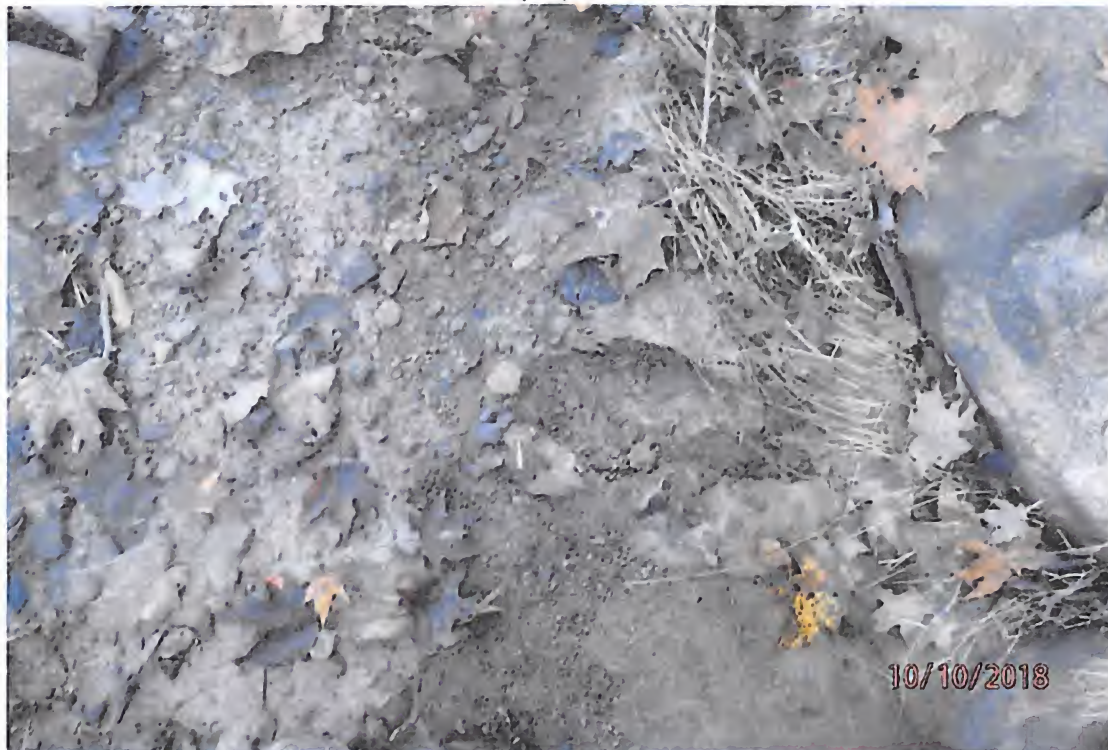
Installed water bar terminus BMP adjacent to 144+00 that caused offsite CNA deposits in UNT Morgans Run ( $39^{\circ}18.509'$  X  $80^{\circ}40.356'$ ).

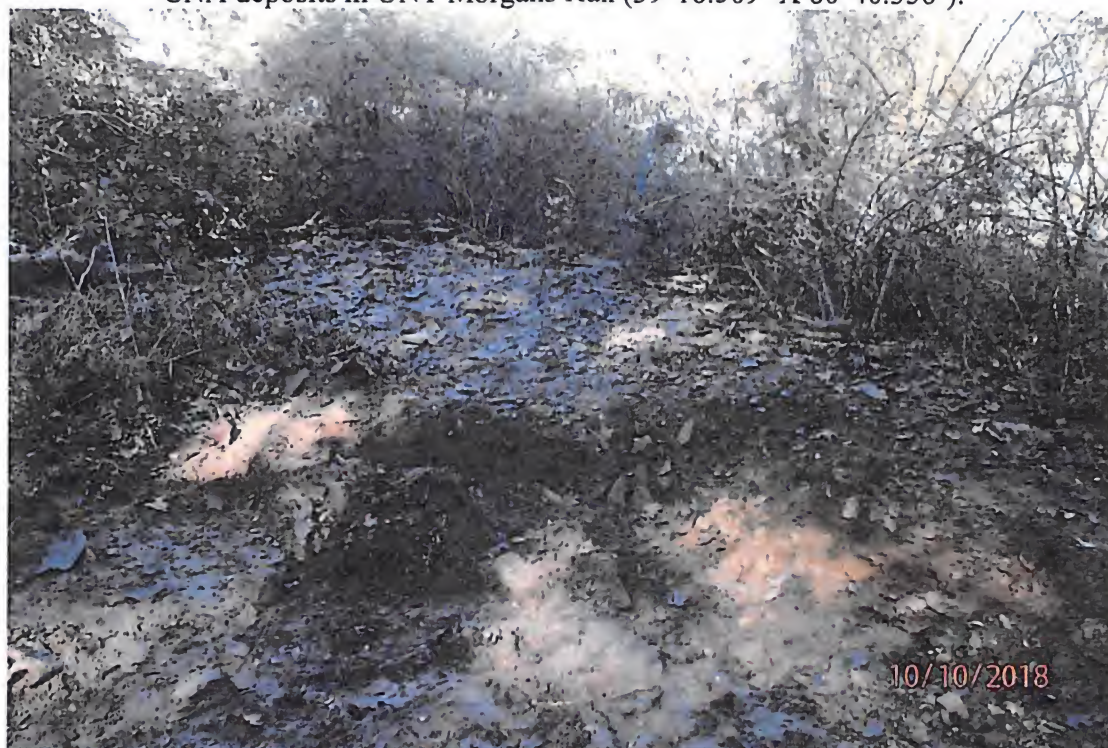
CNA deposits in UNT Morgans Run (39°18.509' X 80°40.356').

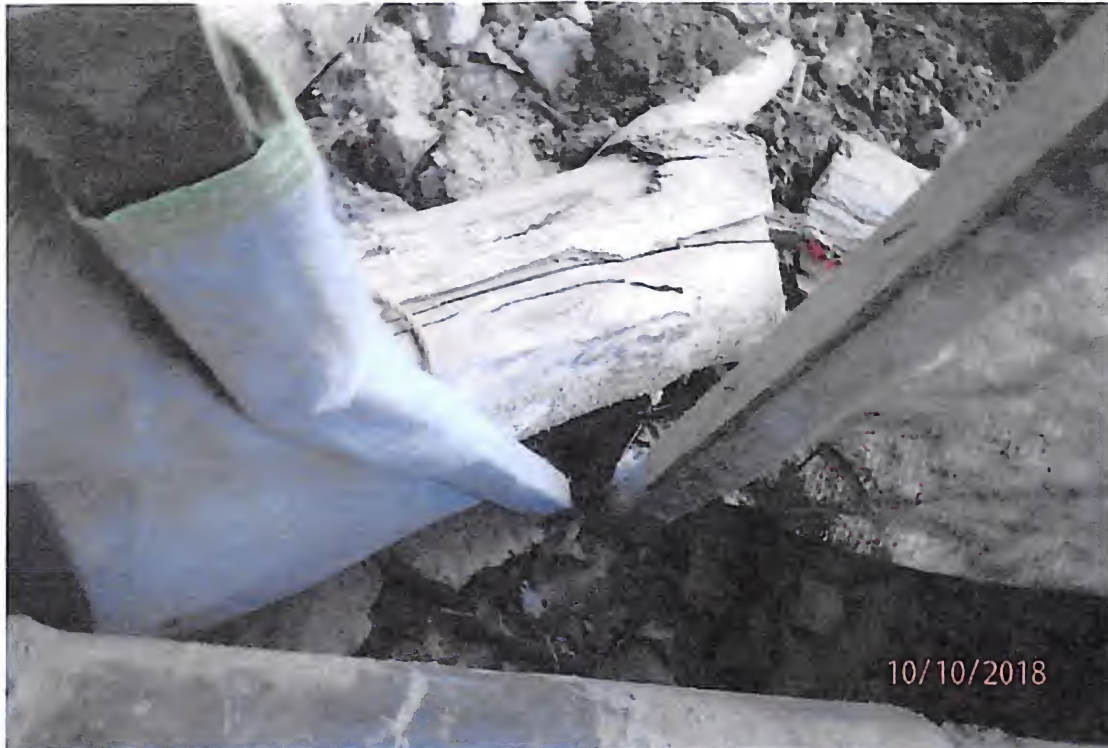
CNA deposits in UNT Morgans Run (39°18.509' X 80°40.356').

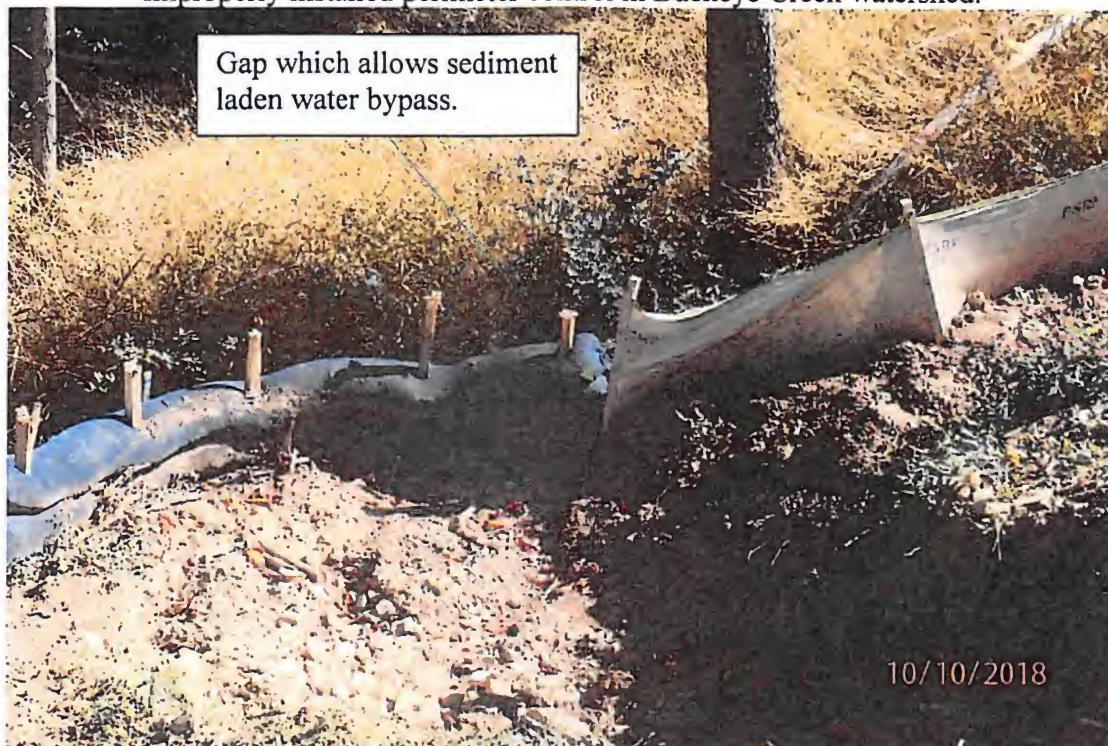
Improperly installed perimeter control in Buckeye Creek watershed.

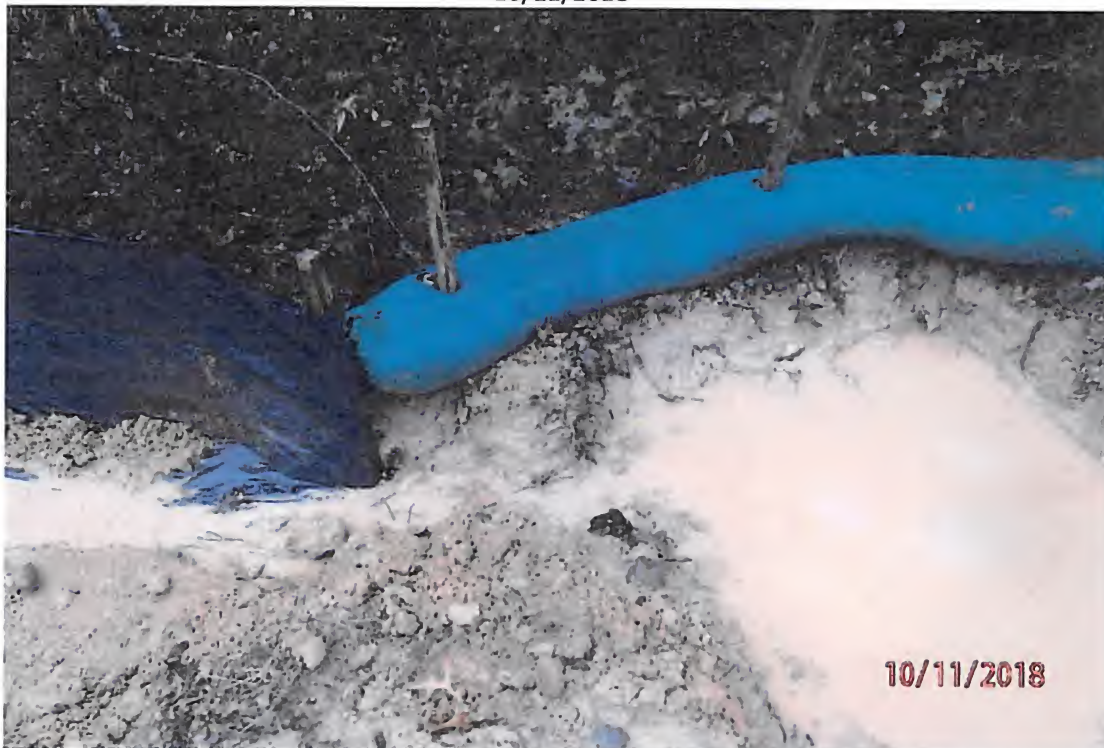
Offsite CNA deposits in UNT Flint Run (39°20.058' X 80°39.931').

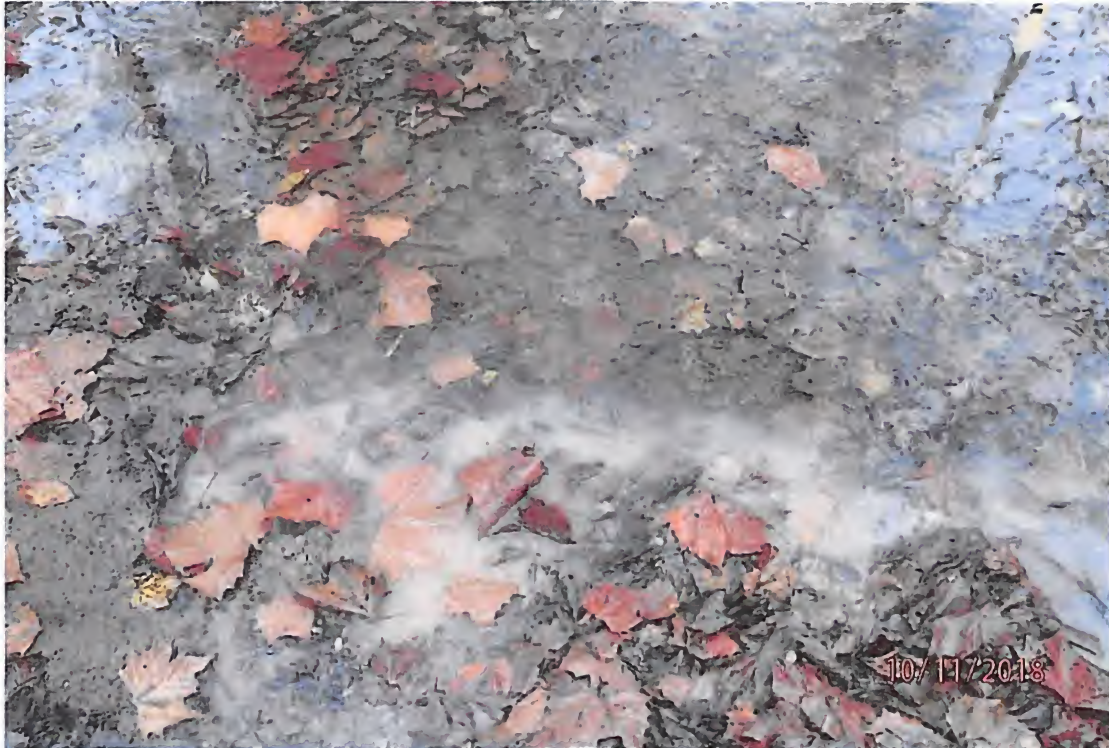
Above pictured bridge showing sediment laden water bypass.

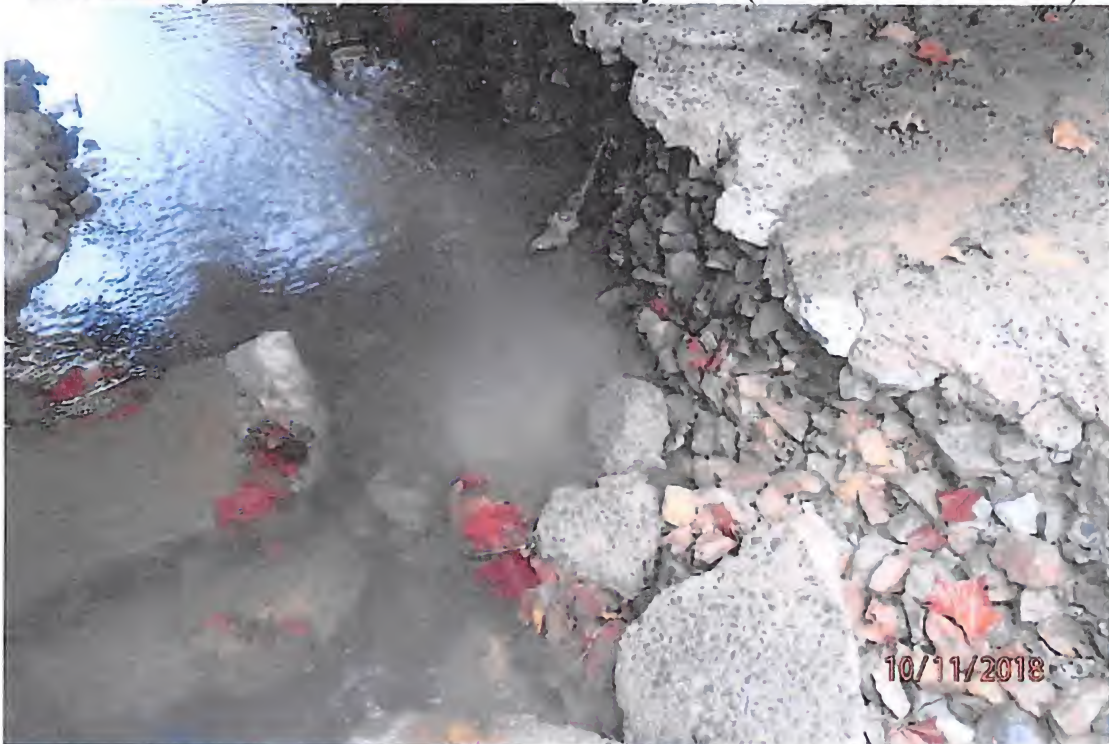
CNA distinctly visible settleable solids in McElroy Creek (39°23.952' X 80°38.768').

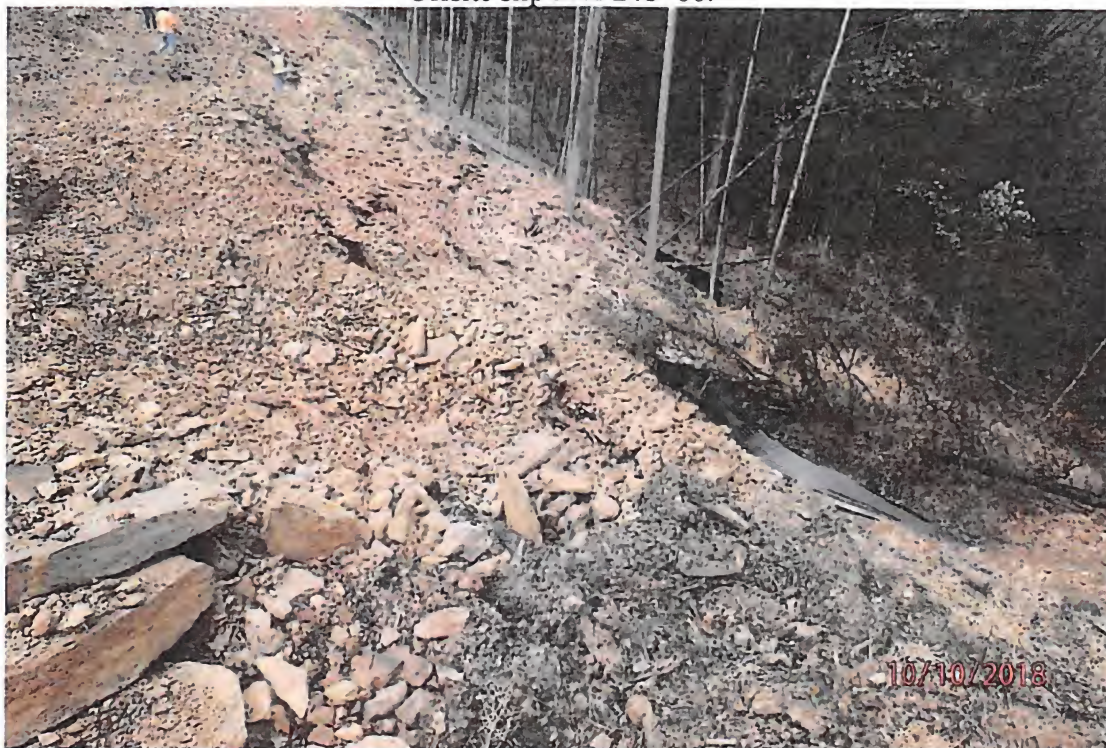
Offsite slip near 248+00.

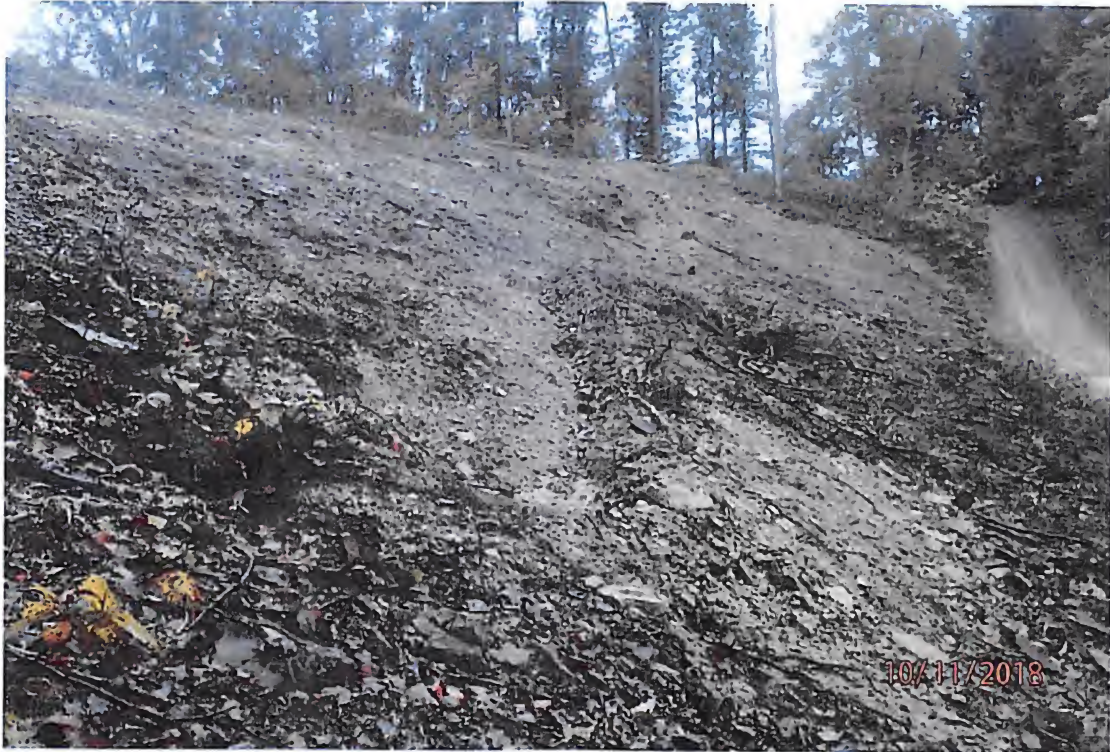
Offsite slip near 479+50.

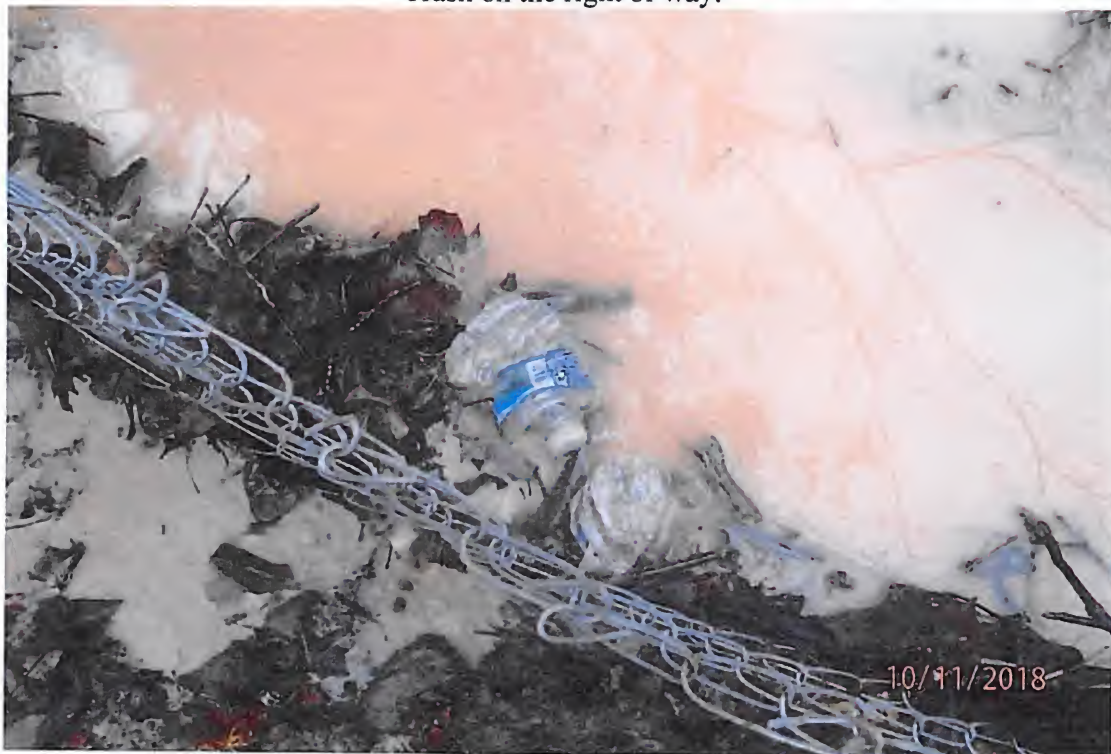
Trash on the right of way.

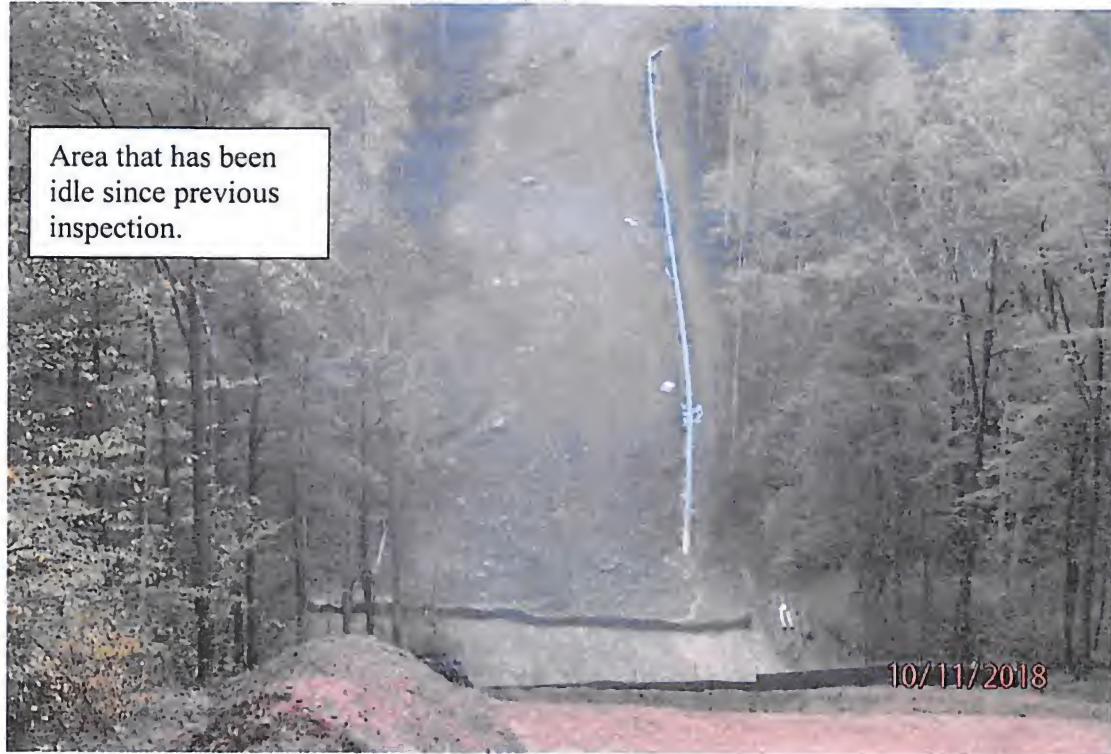
Right of way that lacks temporary stabilization near 862+00.

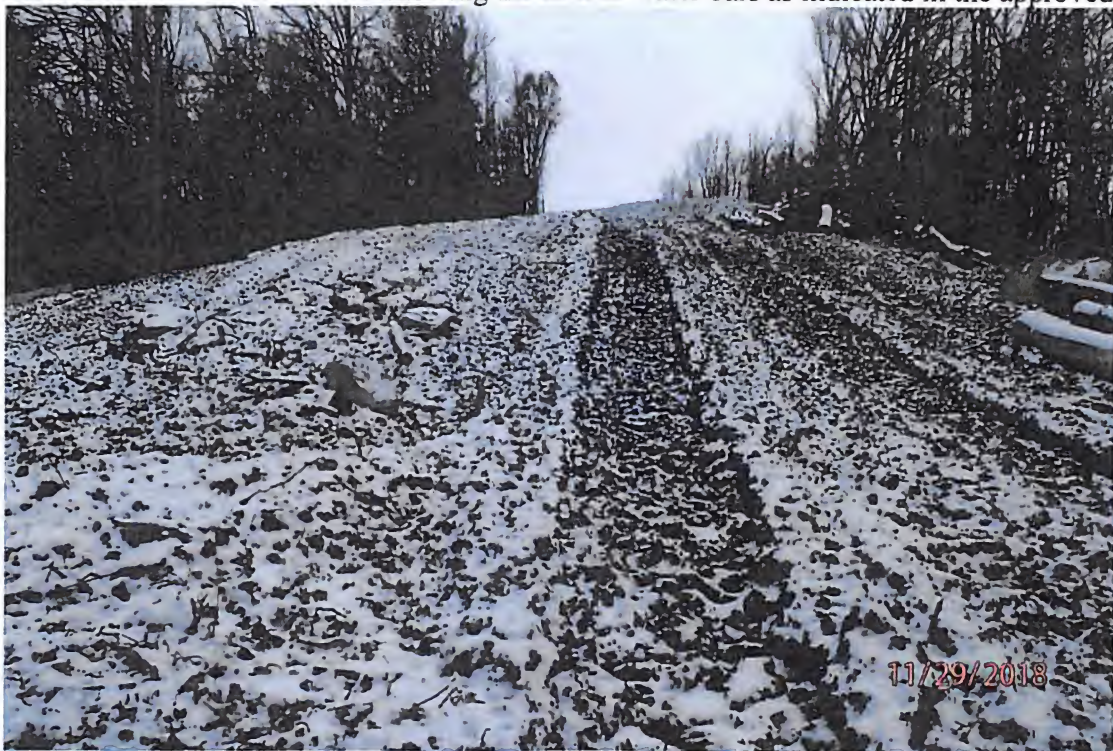
Inspected area from 661+00 to 669+00 showing the lack of water bars as indicated in the approved SWPPP.
